A Closer Look at Plug and Play MPO/MTP Assemblies

This white paper expands the focus to look at the performance of MPO/MTP laser optimized multimode OM3 trunk assemblies and MPO/MTP-to-LC laser optimized multimode OM3 hybrid assemblies. This study includes MPO/MTP Trunk Assemblies and MPO/MTP-to-LC Hybrid Assemblies from Siemon and four different generic assembly houses. Five samples of each assembly were purchased from each manufacturer through standard distribution channels. Siemon Labs tested each assembly to Siemon's specifications, as well as to TIA and IEC standards for end face geometry, cleanliness, optical performance and mechanical reliability. Siemon's specifications are more stringent to ensure superior performance and application assurance for today's high speed fiber applications.

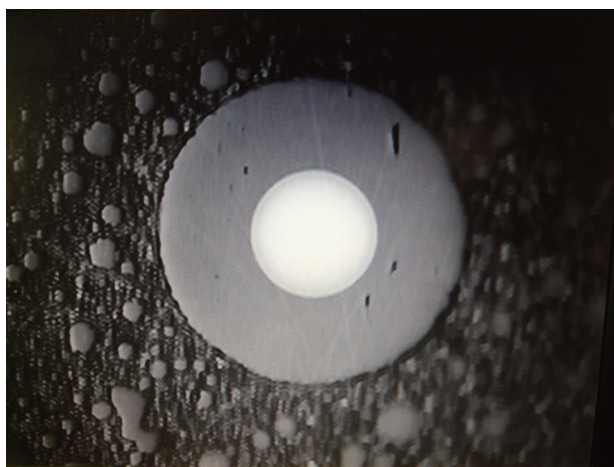
Figure 3: End face Contamination and Surface Defects for MPO/MTP Trunk Assemblies (Note: One fiber end face shown for clarity)

Surface defects and overall fiber end face cleanliness is critical to optical performance, but will not always be detected via end face geometry testing. A smooth but fractured fiber will not necessarily fail end face geometry inspection for angle of the polish and fiber height. The photographs in Figure 3 show the typical end face quality received for the various MPO/MTP Trunk Assemblies and the end face quality received for the sample from Manufacturer A3. While contamination was able to be removed from other samples during the fiber cleaning process, scratches and defects were unable to be removed from the A3 sample, which ultimately caused it to fail the parameter for end face worst case scratch/defect as shown in Table 3. A3 would have failed end face geometry testing regardless since it failed other parameters per IEC.

Typical End Face Quality After Cleaning

Manufacturer A3 End Face Quality After Cleaning

Manufacturer	IEC PAS 61755-3-31
	EF worst case scratch/defect
Siemon	Pass
A1 (MPO)	Pass
A2 (MTP)	Pass
A3 (MTP)	Fail
A4 (MTP)	Pass

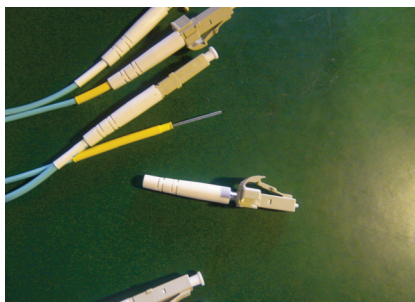
Figure 6: Failed Cable Pull and Cable Flex Tests for MPO/MTP-to-LC Hybrid Assemblies

**Manufacturer A2 LC Side After Cable Pull Test —
Fiber Broke in Connector**

**Manufacturer A3 MPO/MTP Side After
Cable Pull Test — Fiber Broke in Connector**

**Manufacturer A4 After Cable Pull Test —
Furcation Tube Separated from Breakout**

The MPO/MTP-to-LC Hybrid Assemblies were subjected to the same mechanical stress tests as the MPO/MTP Trunk Assemblies with the results shown in Table 7. All samples except for those from Siemon exhibited fiber failures occurring in either the Cable Pull and/or Cable Flex testing.

The mechanical tests provide an indication as to whether the MPO/MTP-to-LC Hybrid Assemblies can withstand installation and maintenance without subject to failure or degradation in optical performance. It is evident that the construction of the breakout/furcation system of hybrid assemblies has a major impact on mechanical reliability.
